Biotopia Report ID: 200205-1 [redacted]
Address: [redacted] Avonsleigh VIC 3708
Owner/occupant: [redacted]
Date of Attendance: 5 February 2020
Date of Report: 11 February 2020

EXECUTIVE SUMMARY

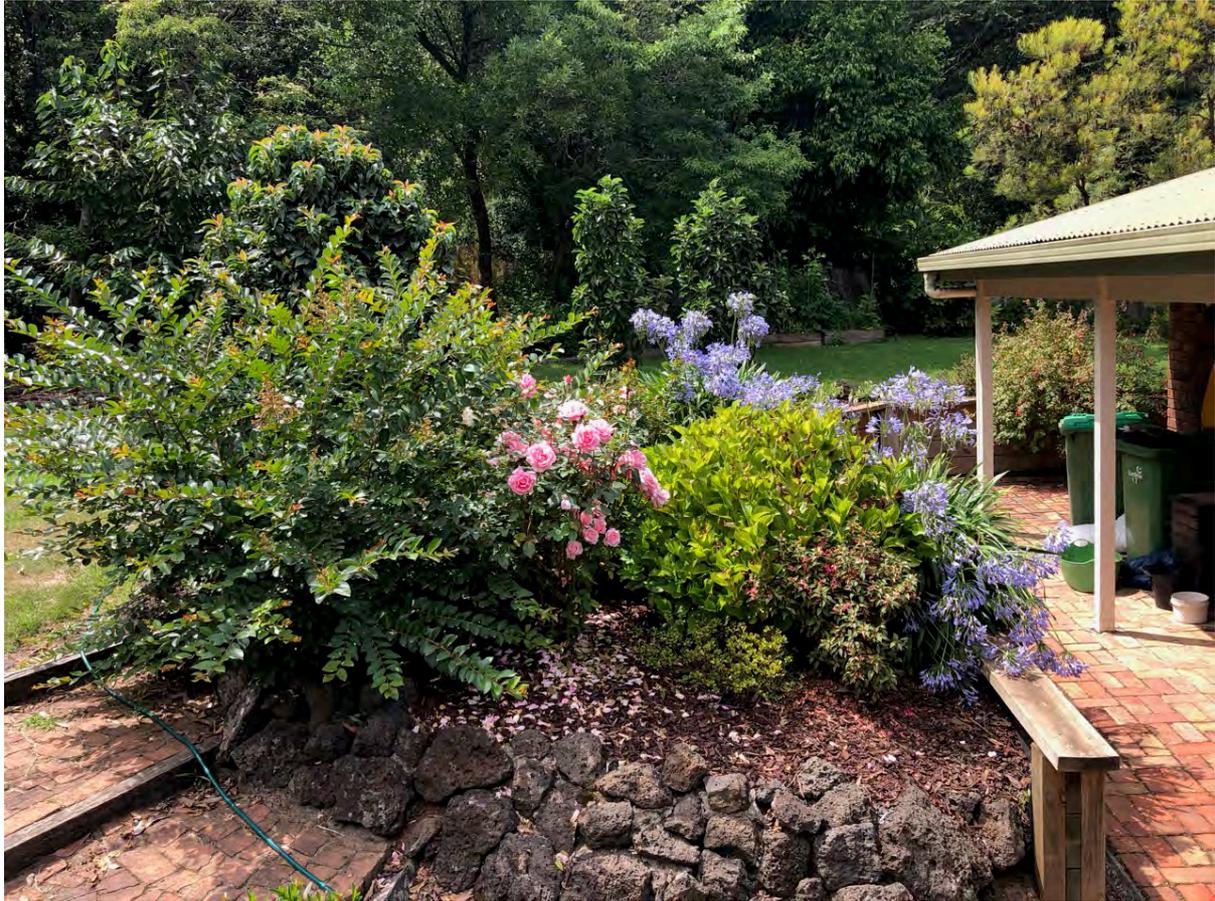
Noted significant dampness in the soil some 15-20 cm or so under the brick pavers, seemingly under a membrane given the slight resistance offered when the soil moisture meter was inserted in a small number of locations.

It is likely the high-rainfall area and long, significant slope towards the house have contributed to significant surface and more importantly, subsoil water flows that are not adequately intercepted at the earth-retaining walls at the brick paved areas nor the shallow concrete gutters, traveling under the brick pavers and putative plastic membrane towards the house, contacting the sides of the slab at the master bedroom near/at the window, penetrating into it.

2. The noted slope towards the house, with earth-retaining wall. This may or may not have drainage assets, but it is unclear where they flow, or if they are still intact / not crushed. Noted flex aggie pipe under the decking (not visible, behind/left of image) is not encouraging.

An engineer or other professional with experience in hydrogeology and civil engineering / drainage should be consulted specifically regarding the design and installation of drainage assets to prevent surface and subsoil moisture flows from reaching the house. In my most humble non-engineer opinion, the installation of a French trench drain around the high-sides of the house may be of great benefit. These drains are typically cut/dug perhaps 1 m deep via a 'Ditch Witch' or similar earthmoving machine, and perhaps 200 mm wide, lined with geo-tex or similar non-degrading mesh to keep the soil at bay, then a slotted pipe of suitable strength and diameter to accommodate the weight/pressure of WET soil above and laterally (often the cause of pipes being crushed). Ideally the slots are placed facing down to better drain water that otherwise pools until it rises above the height of upwards-facing slots. A suitable gradient to similar facilitate free drainage and removal of debris, silt, etc., is

also advisable. The trench is then filled with 1-2 cm rocks or pebbles to allow the free movement of water straight down, and not 'bridge' through the soil that came out of the trench in the first place, which may lead to disappointment. Usually the geo-tex is folded over the top of the pebbles, and in many instances decorative pebbles or a grate is placed over the top, sometimes even a layer of turf, but this tends to dry out.

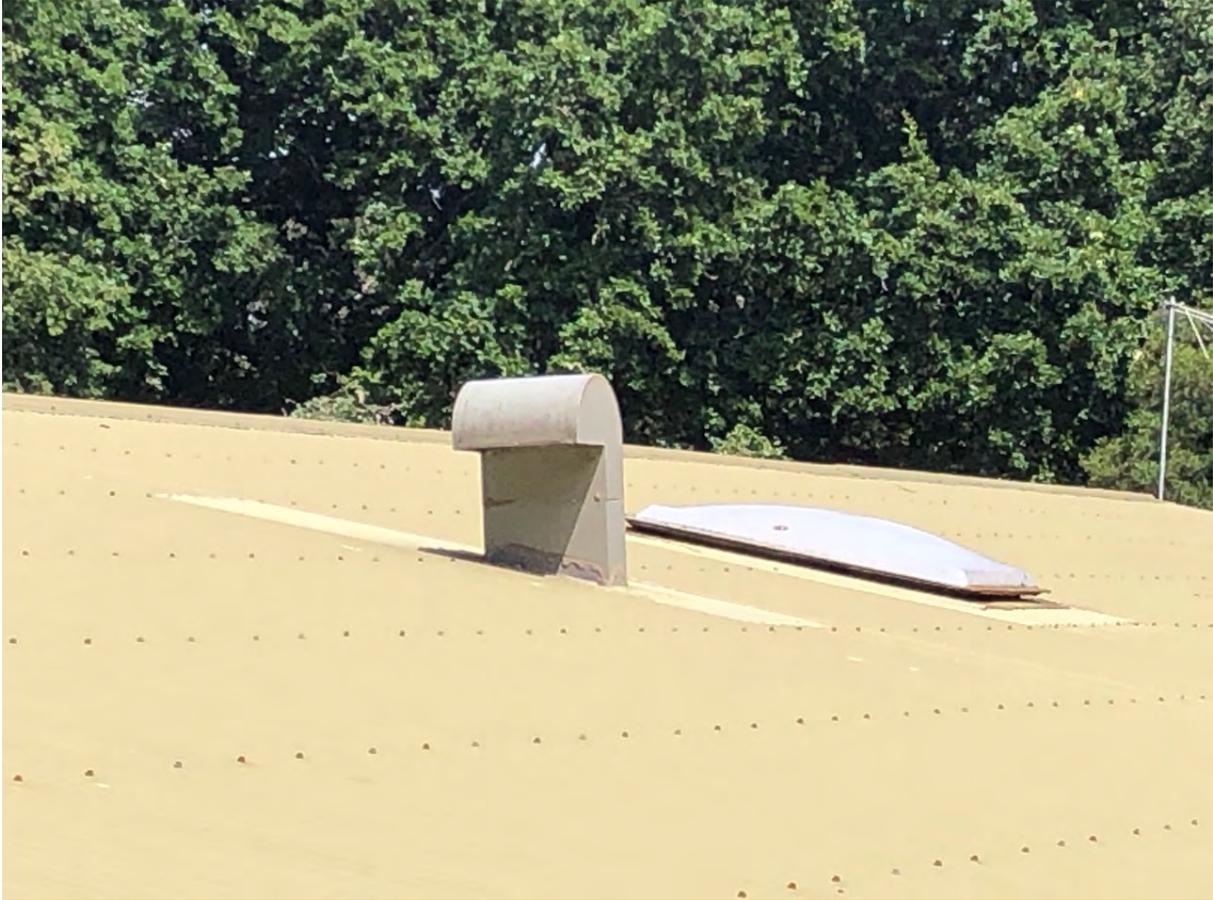
3. The kitchen rangehood vent and kitchen skylight: it was difficult to see if the corrugated metal 'upward' of the rangehood vent is correctly inserted under the roof metal itself (forming an overlap water falls over) or is instead merely stuck on top of it, which tends to lead to disappointment. It is also unclear if the vent is indeed flashed correctly, or if the different colouration is in fact silicone / caulking. Similar comments are made about the stink-pole (not visible), but the rubber boot seems OK at the moment: it is highly encouraged all such roof assets be inspected periodically for weathering, degradation, splitting, etc., and repaired/replaced accordingly.

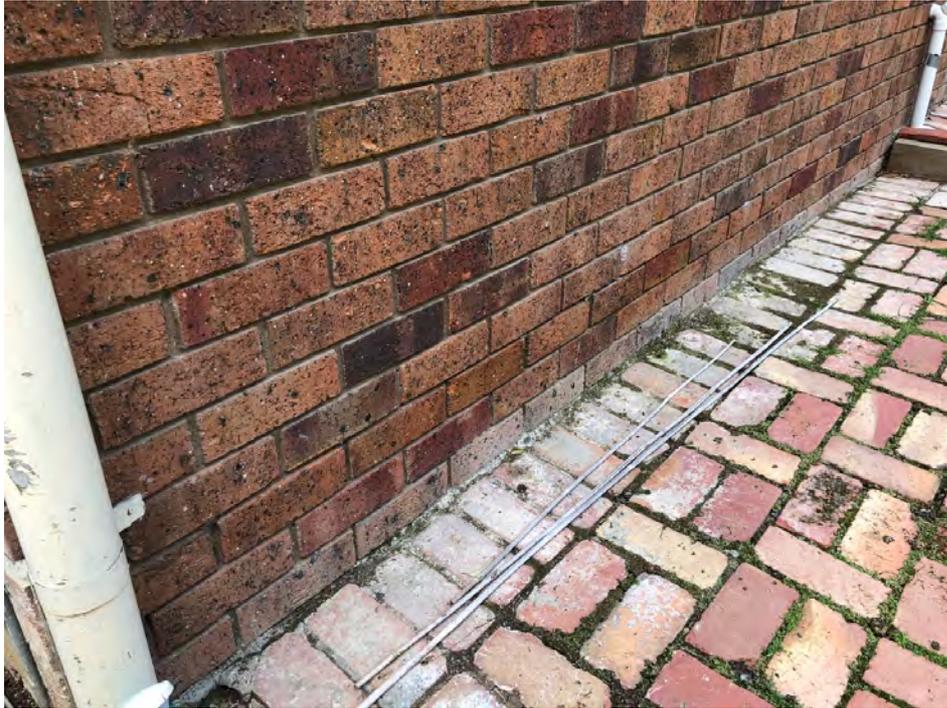
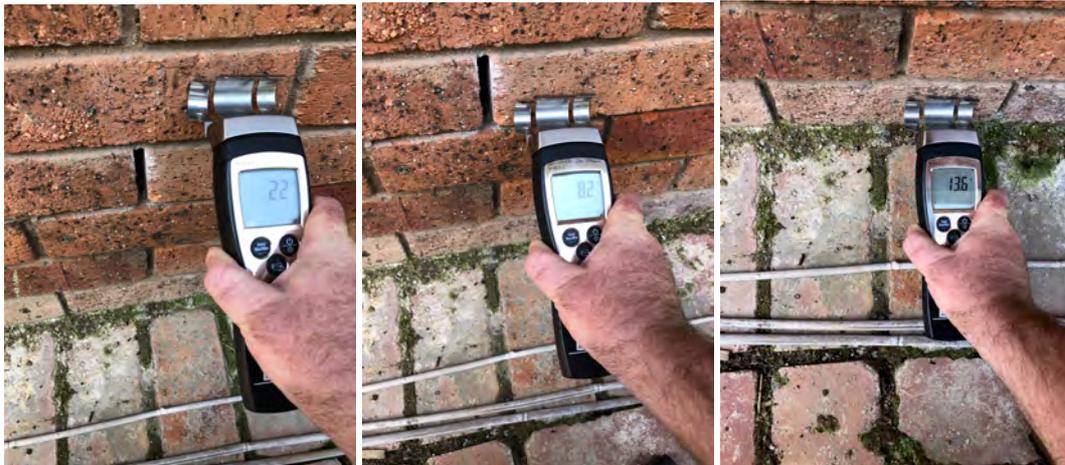
It was further noted there was dampness under the slab / at the bricks to the side of the house at the furthest corner from the high side, near the laundry.

It is therefore possible that moisture is flowing entirely under the house but only penetrating whatever waterproofing plastic sheeting there is at a few sites, presumably where there are holes or inadequate sealing / overlapping of adjacent sheets, and/or where plastic at the side of the slab has been damaged/removed or such. This is not unusual.

4. The noted dampness and mineral salt efflorescence at the low-side of the house near the laundry (right). "Dry" is typically 2%MC or less.

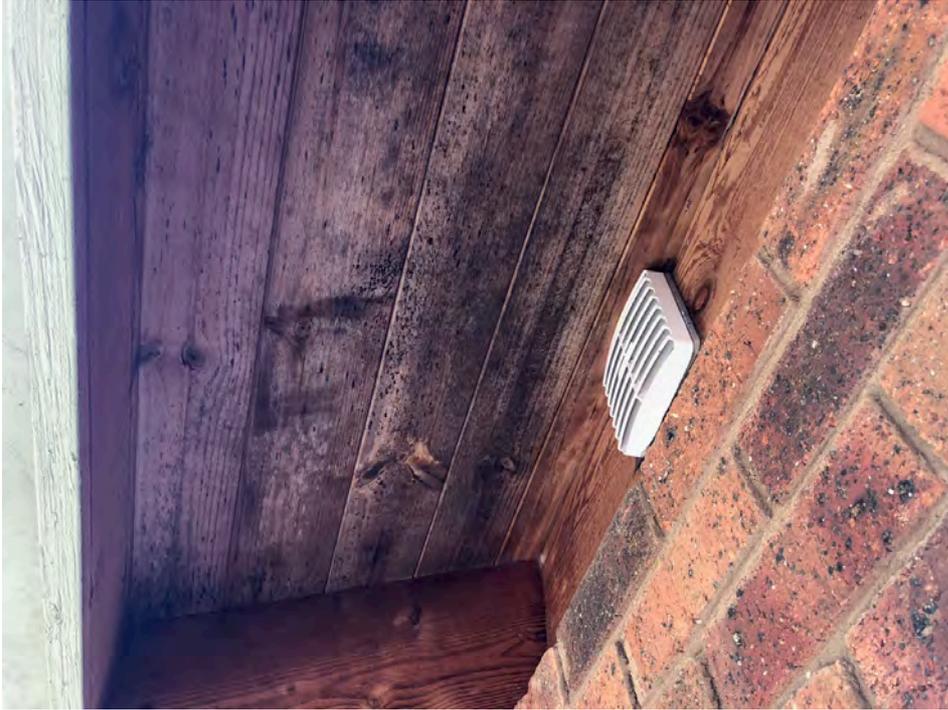
Fascinating amount of visible dark-coloured fungi under the eaves on the soffits at the exhaust ports from the bathrooms suggesting frequent condensation and consequent damage.

This has also caused biological activity and water damage at secondary sites of condensation such as single-glazed window panes / frames, and the soffits where damp air from the bathrooms is exhausted. It is likely there is biological activity within these exhaust ducts based on experience. Ideally such ducts would be larger diameter and well insulated to prevent condensation, and ideally run for longer to aid drying them out. Replacement is typically cheaper, easier and more effective than cleaning. Installation of a separate set of fans over each shower would also be of benefit, especially if they were somehow wired to run for a set time after use of the shower, and ideally turning on when greater humidity than outdoors is detected. These used to be available at Bunnings some years ago, but not seen recently.

5. The noted mould on the soffits at the master bedroom en suite bathroom fan exhaust.

- 3.5. Seal up HVAC ductwork, vents, louvers, registers, electrical appliances (ovens, fans, etc.), fixtures/fittings (inc. lights, power-points, switches, ports, conduits), and/or remove them. Definitely remove the narrow-bore ducts from the bathroom exhaust fans (to be replaced with insulated larger new ones later).

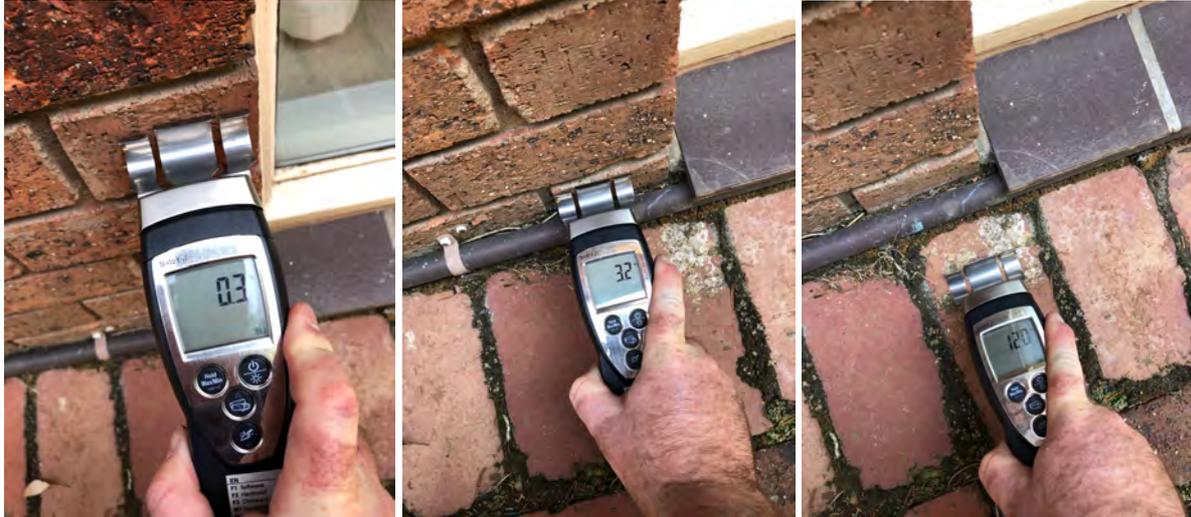
6. The master bedroom window surround: damp low down.

- 3.6. Master bedroom wall around window / Son's bedroom around window: remove skirting boards and plasterboard wall panels from floor to ceiling and remediate surfaces. Discard any fibrous insulation. Check any membranes on both sides for staining/damage/possible growth/signs of condensation

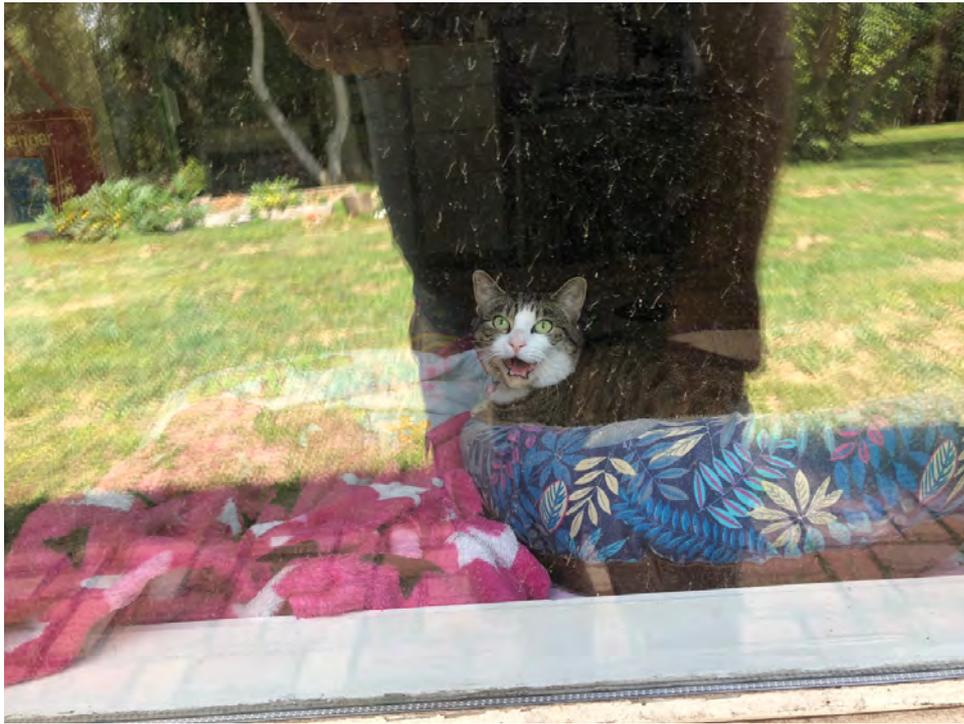
7. The daughter's bedroom with notable Cladosporium mould spots on the panes. And hissy-kitty.

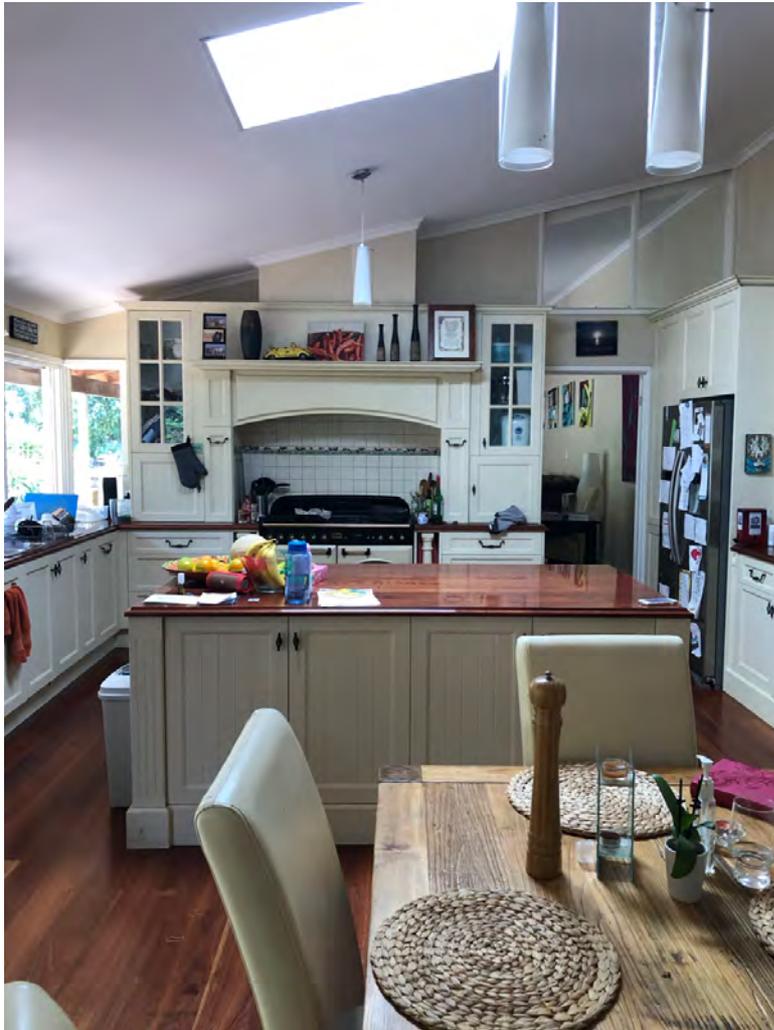
8. The well-appointed kitchen and meals area. Owner said no water was ever noted leaking from skylight or rangehood. Did note mould within the skylight shaft, however, which may be consistent with condensation rather than a leak. Difficult to read moisture in the slab through the thick timber engineered floor coverings.

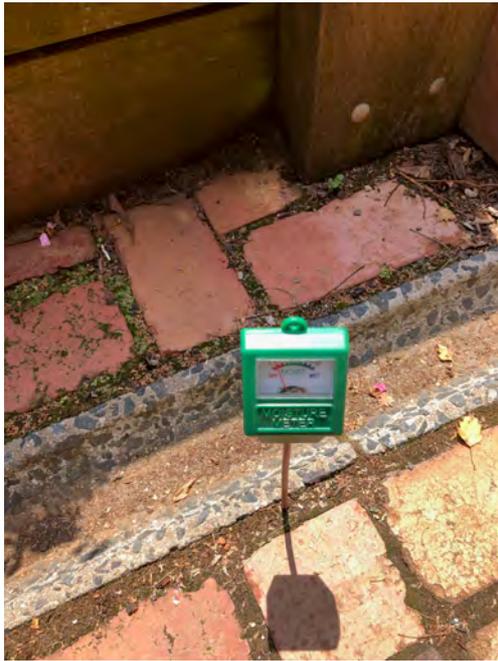
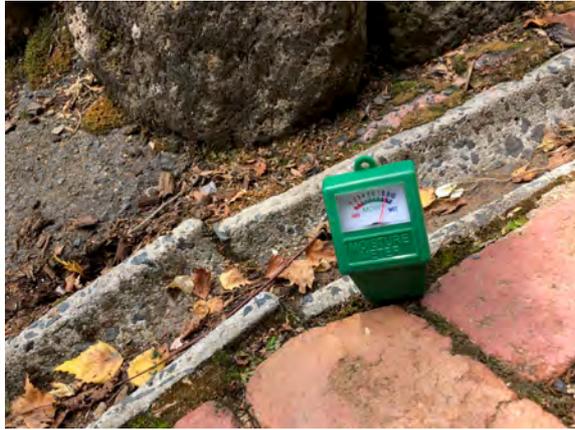
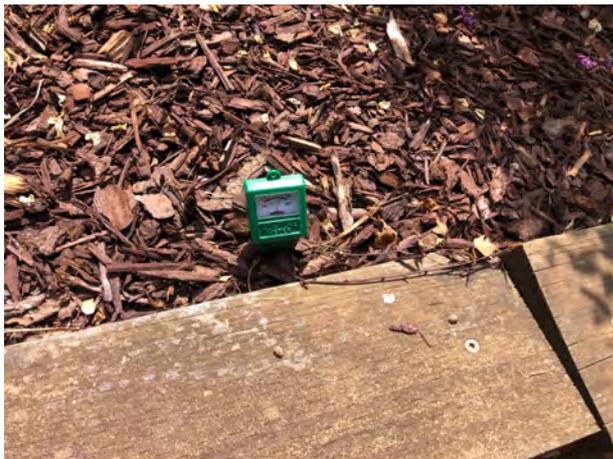
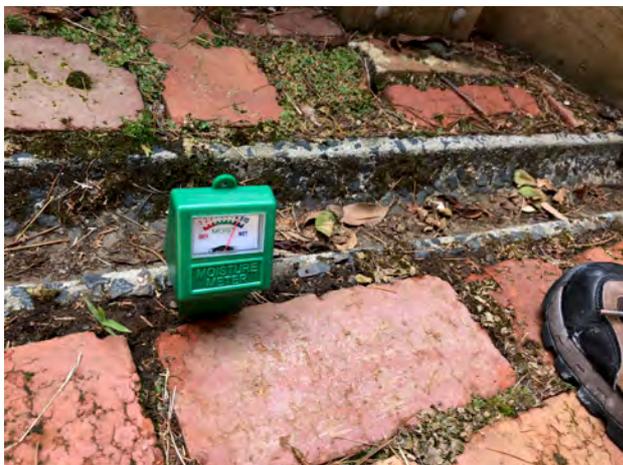
10. The soil at the high-side of the house: noted difference in dampness between approx. 10-15 cm (dry) and 15-20 cm (wet), below a possible plastic membrane or similar.

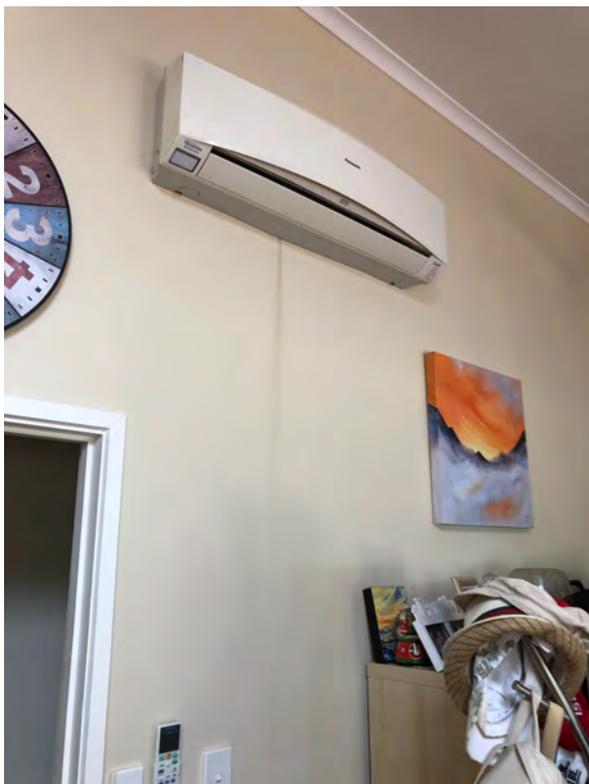
12. The kitchen A/C did have water staining below it. Possibly a blockage of the quite long condensate pipe that runs all the way to the eaves. Does happen, requiring an occasional flush-out.

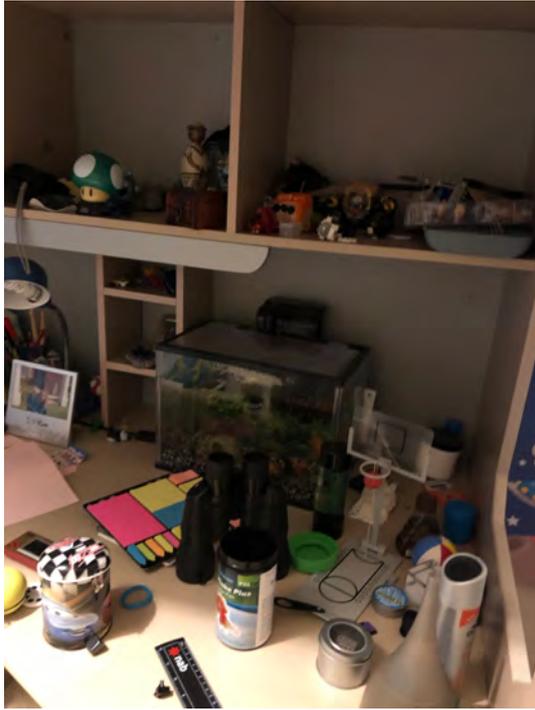
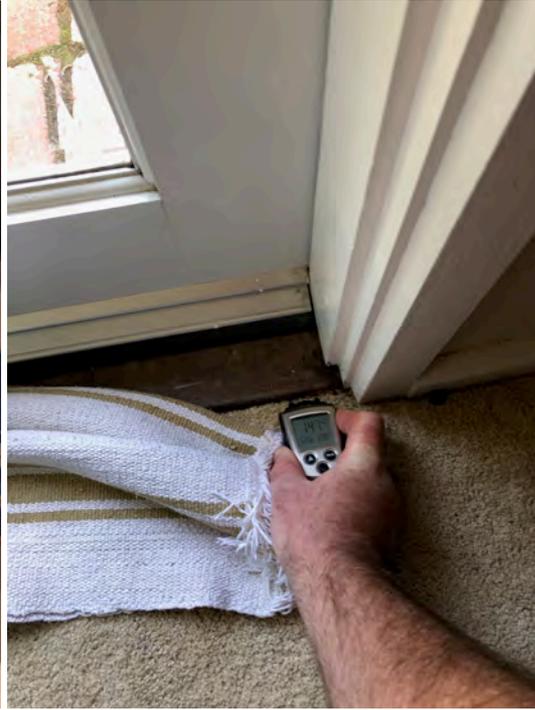
It was also noted there was dampness in the slab at the son's bedroom window, likely the cause of significant mould found in the room. This was curious as it was some distance from the high-side of the house and side window / master bedroom.

14. The son's bedroom. Dampness detected at the door/window frame threshold.

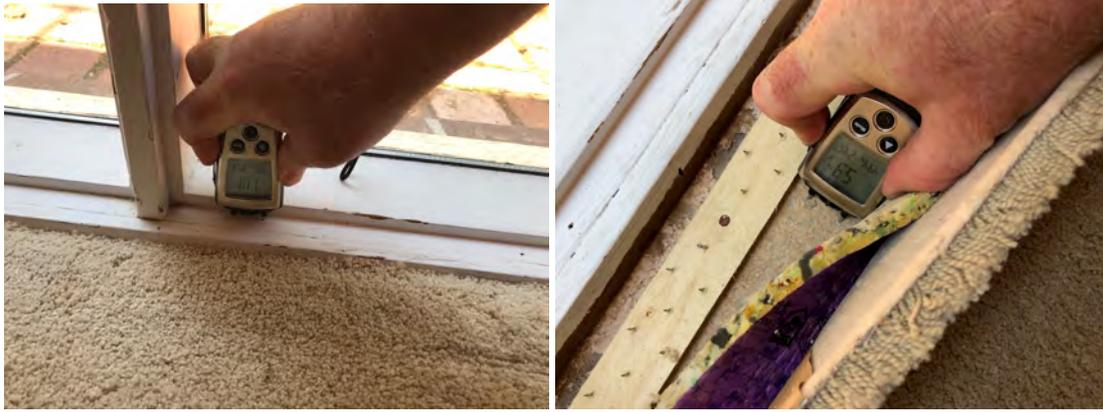
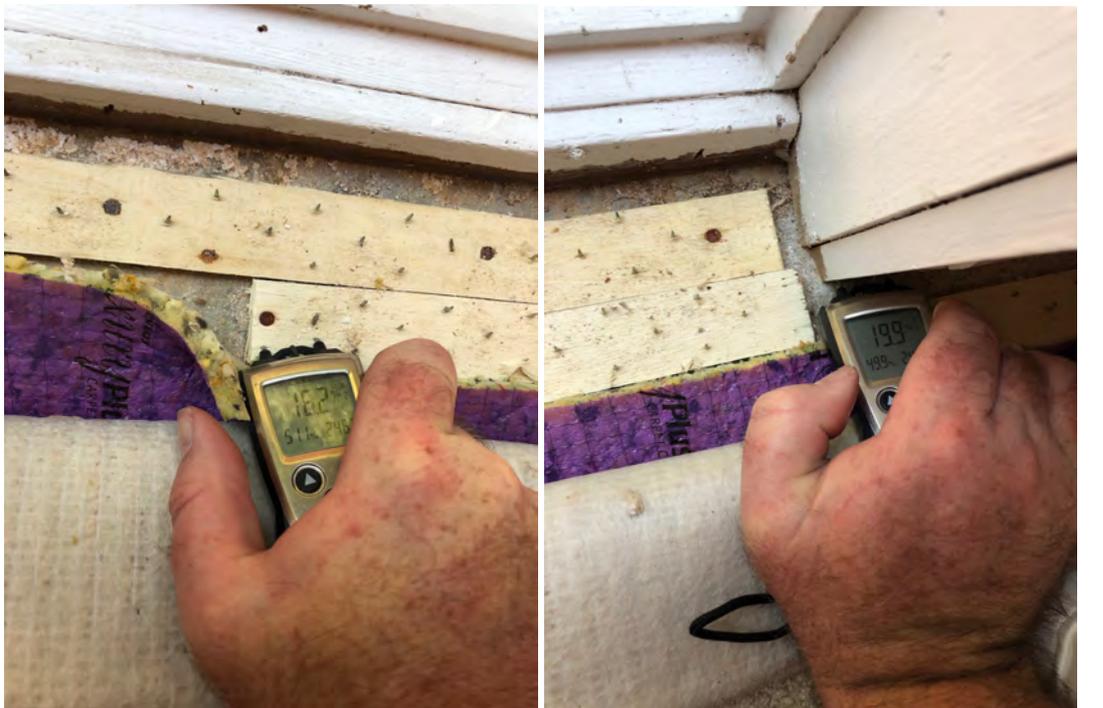
Son's bedroom and the master bedroom are especially damp and mouldy including signs of moisture/condensation on windows via damage to window frames/sills, moisture measurements of the slab especially at the periphery / near windows, noted mineral efflorescence under the carpet especially in the master bedroom. Corrosion / rusting of the metal tacks on the smoothedge/tackplates and some visible mould.

15. The master bedroom windowsill. Significant dampness in the slab.

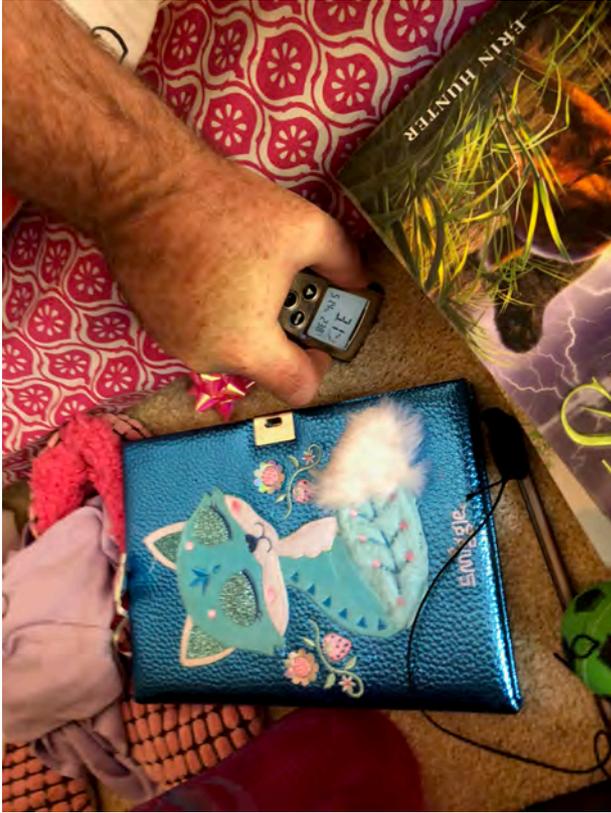
16. The master bedroom slab under the daughter's temporary bed was quite damp.

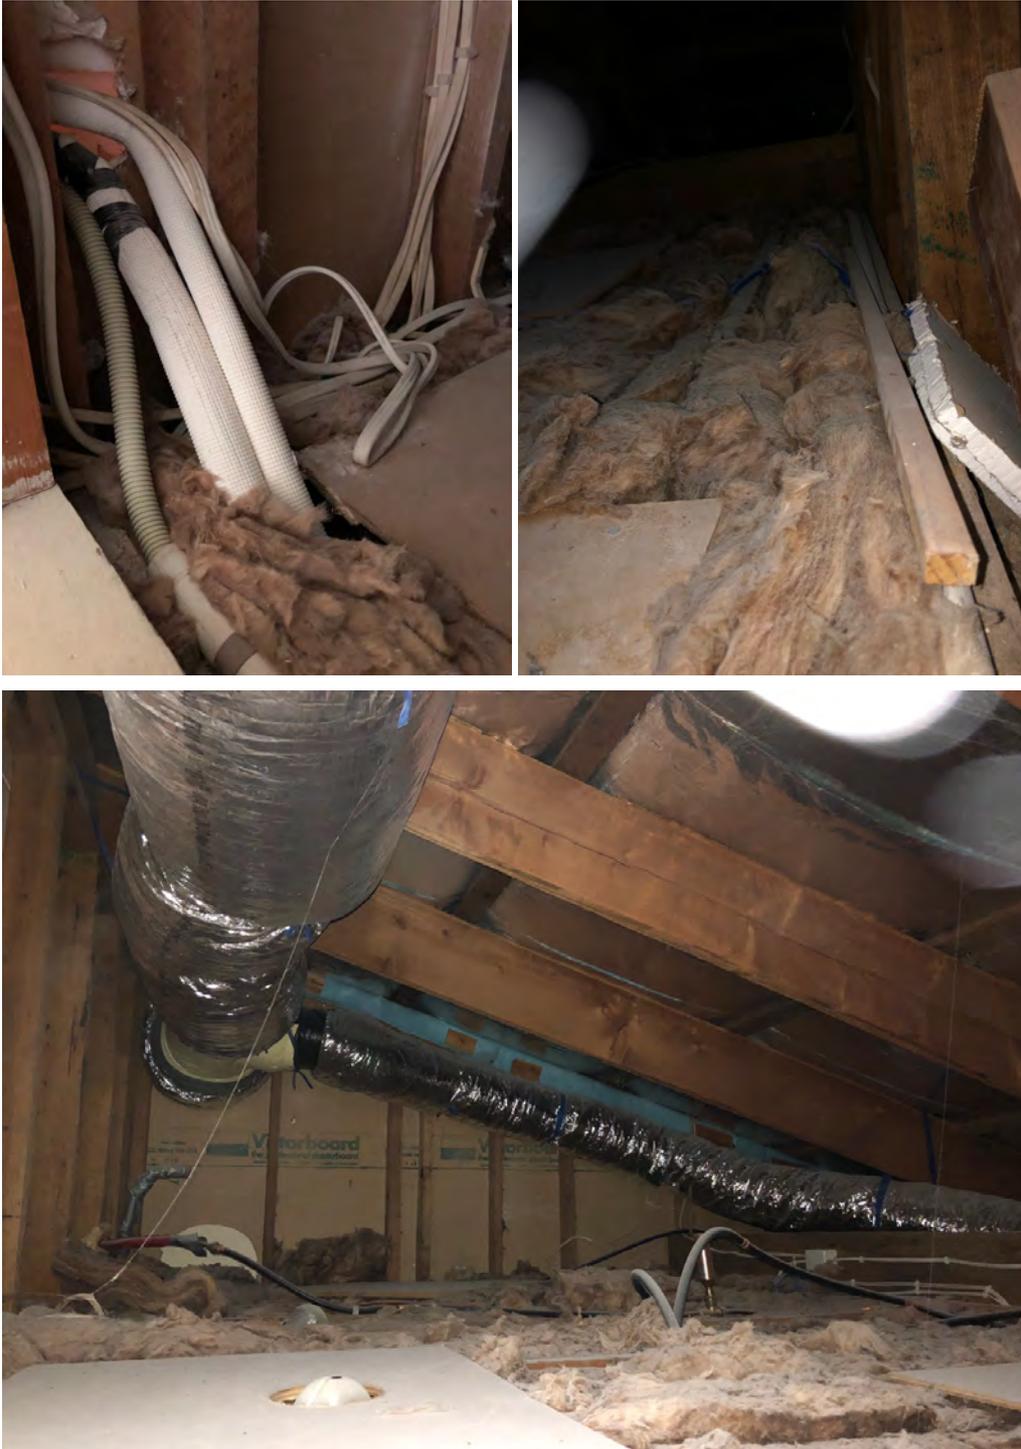
17. The roofspace. Noted anticon reflective blanket under metal roof. Unclear if water ingress into the fibrous insulation above it. Generally seems pretty dry here, but would benefit from 'whirlybirds' to assist removal of significant moisture rising up from the damp slab.

Installation of 'whirly bird' roof vents or similar may be good. These may improve energy efficiency and comfort, and limit potential condensation in general.

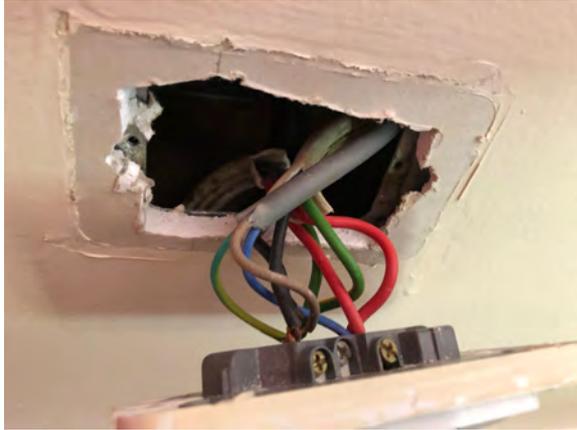
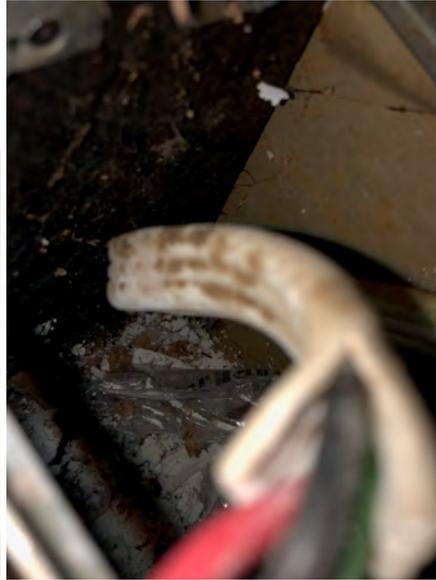
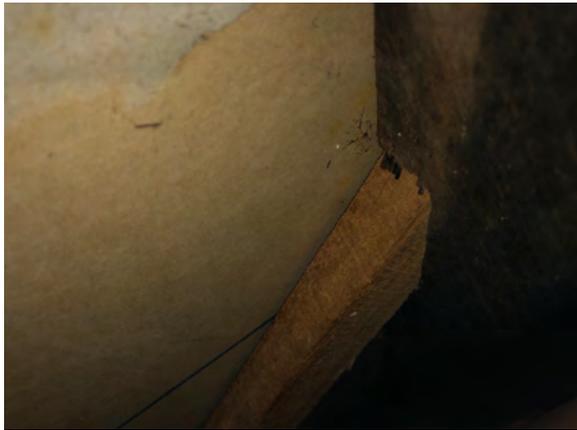
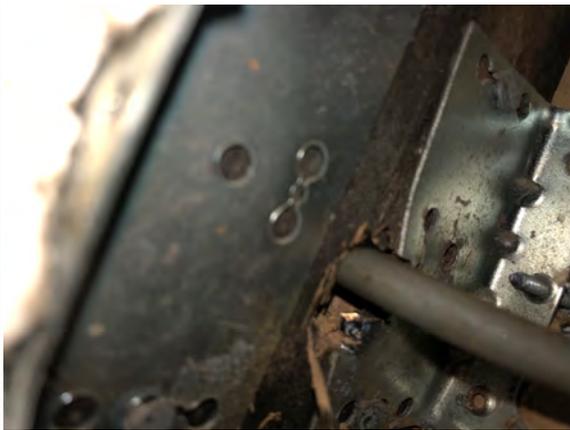
18. The power point in the living room next to the fireplace, facing into the wall to the master bedroom. This was the closest access point to the noted moisture in the master bedroom wall near / under the window.

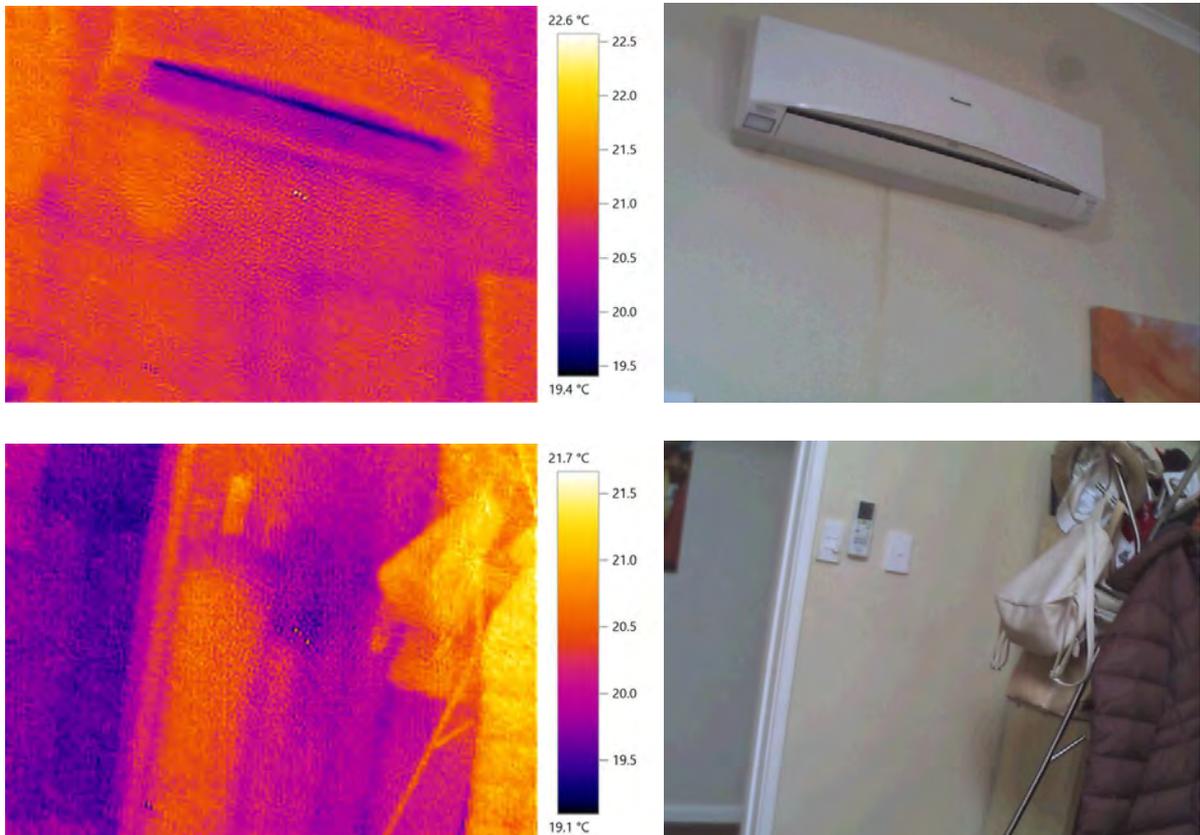
| 10. THERMOGRAPHY | No thermal significant features consistent with current moisture observed in locations suitable for this type of assessment such as plasterboard walls, ceilings. Possible slight dampness under the A/c unit in the kitchen, but not much. |

21. Thermography of kitchen A/C: seems dry enough underneath. Possible slight damp patch low down / at the noggings. Often an occasional overflow in humid weather, and/or the condensate pipe is leaking / blocked.
